# The Neverlake: Water and Land Management in a Dry and Soiless Place: A Micro Case in the Long Run (Classical Karst from the Seventeenth to the Twenty-First Century)

**Aleksander Panjek**

**Gregor Kovačič**

## Presentation of the Research Question and Štanjel

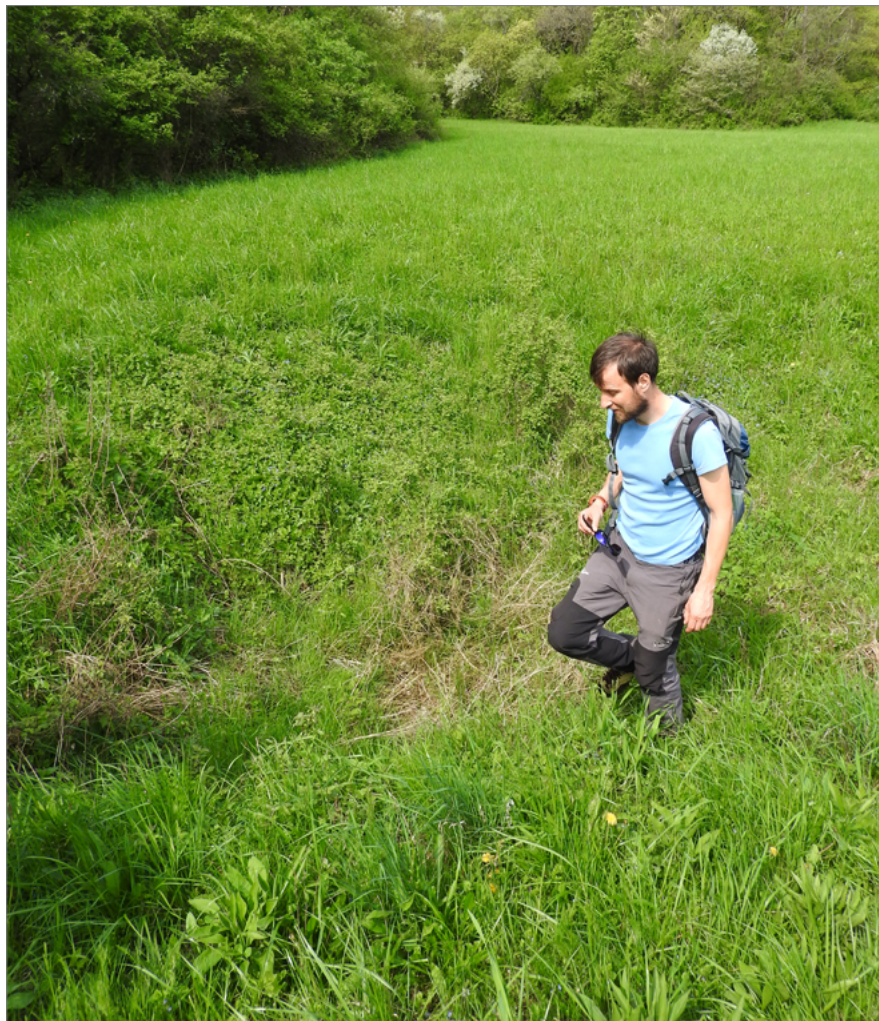
**Figure 2** Gregor Kovačič Next to the Ponor in the Lowest Part of the Jezero doline

alluvial fan of boulders and gravel. The erosional gullies are therefore inherited forms of fluvial denudation, completely cut into the carbonate bedrock. The main ponor at the bottom of the doline is a small depression with a diameter of 4 m and a depth of 1 m (figure 2). We can only guess at the direction of subsurface drainage from the ponor, but it is likely that it flows underground to the northwest, to the Timavo River karst springs on the western edge of the Karst, just as most of the infiltrated rainwater in the Karst does.

Although today the predominant process of surface transformation in this area is corrosion, man-made structures from the past indicate periodic torrential activity. Torrents sink into sediment-covered ponors at the bottom of the doline. The water retained in the lowest part of the doline on such occasions and the resulting swampiness undoubtedly gave the doline its name – ‘Jezero’ (‘Lake’) (figure 2 and 3).

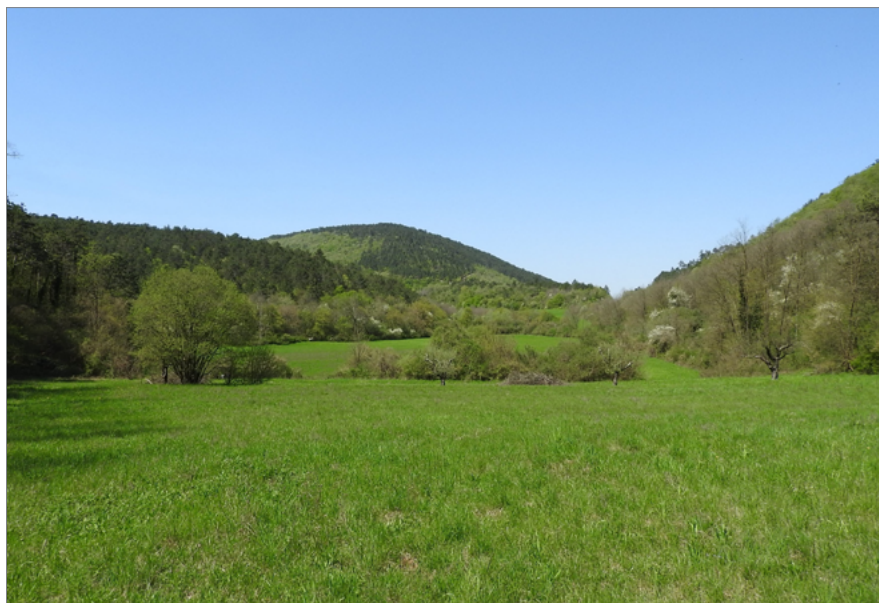
**Figure 3** View of ‘Neverlake’

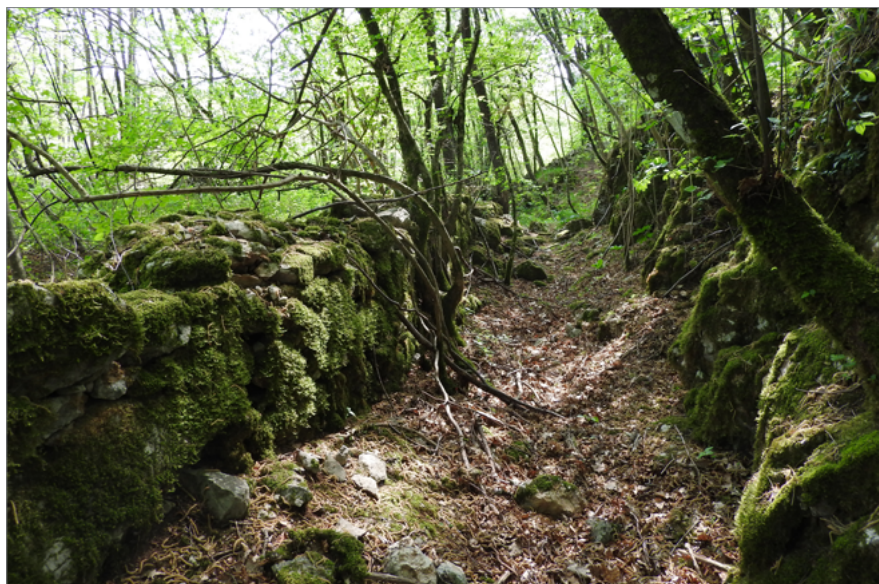
**Figure 4** Regulation of the Erosion Gully, Northwest of the Jezero doline

This interpretive section of this chapter draws on geographic knowledge, historical and oral sources, and the results of a detailed analysis of the LiDAR image of the 'Neverlake' area. The information obtained is synthesized into a coherent reconstruction of the construction activities associated with draining the lake, the initial reasons and results, and the subsequent changes over time. The northwestern, i.e. largest, erosion gully that opened into the Jezero doline was regulated in the lower part by enclosing its left side with an embankment made of gravel; on its right side, a dry stone wall was built, creating a canal for the running water (fig-

ure 4), which flowed in a controlled manner into the northwestern part of the doline bottom. At the very northwestern edge of the doline, they constructed a transverse erosion barrier to retain larger sediments that would otherwise deposit uncontrollably on the cultivable lands and reduce its fertility. The barrier is clearly visible in the shaded LiDAR relief and is also shown on the main topographic map at a scale of 1 : 5,000 (figure 8). The barrier reduced the erosive force of surface water, thereby reducing the effects of water-induced erosion of the soil that property owners occasionally faced. This barrier also acted as a more permanent reservoir, as it is clearly coloured blue in the Franciscan Cadastre (figure 6). An artificially constructed channel led off from the transverse barrier through which water drained toward the centre of the doline. The barrier did not impede the transport of fine-grained sediments, which the water washed along the canal into the lower part of the doline, increasing the fertility of the soil; the canal also served to supply water for irrigation

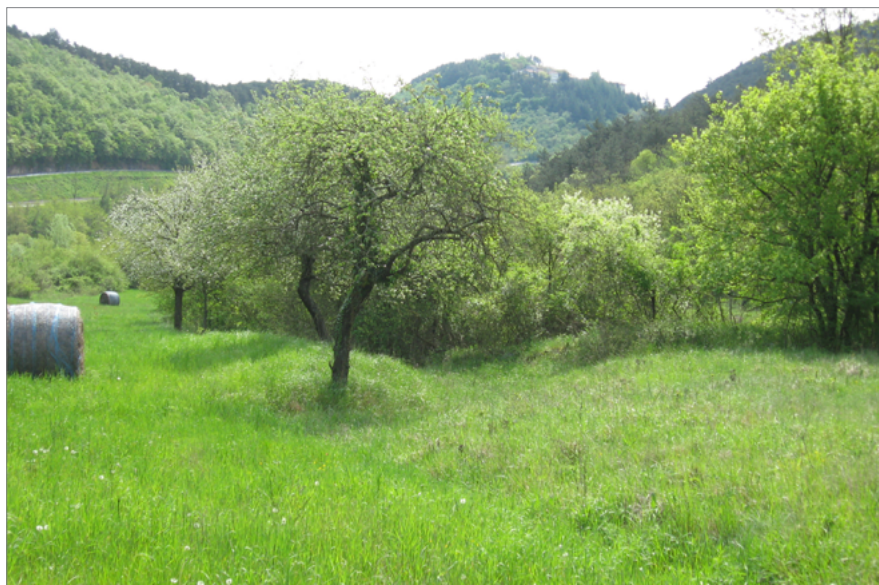
**Figure 5** The Canal of the Intermittent Torrent Runs Along the Middle of the Rubbly-Gravelly Alluvial Fan

purposes. The canal runs through the middle of the alluvial fan (figure 5). Geomorphologically, by constructing the barrier, people have to some extent fossilized the existing alluvial fan that extends from the north-western part of the doline towards its bottom and that was still active in earlier centuries. On the map in the Franciscan Cadastre the transverse barrier is shown as a body of water because the water was retained behind the embankment; when there was no water, the land was soggy (figure 6).

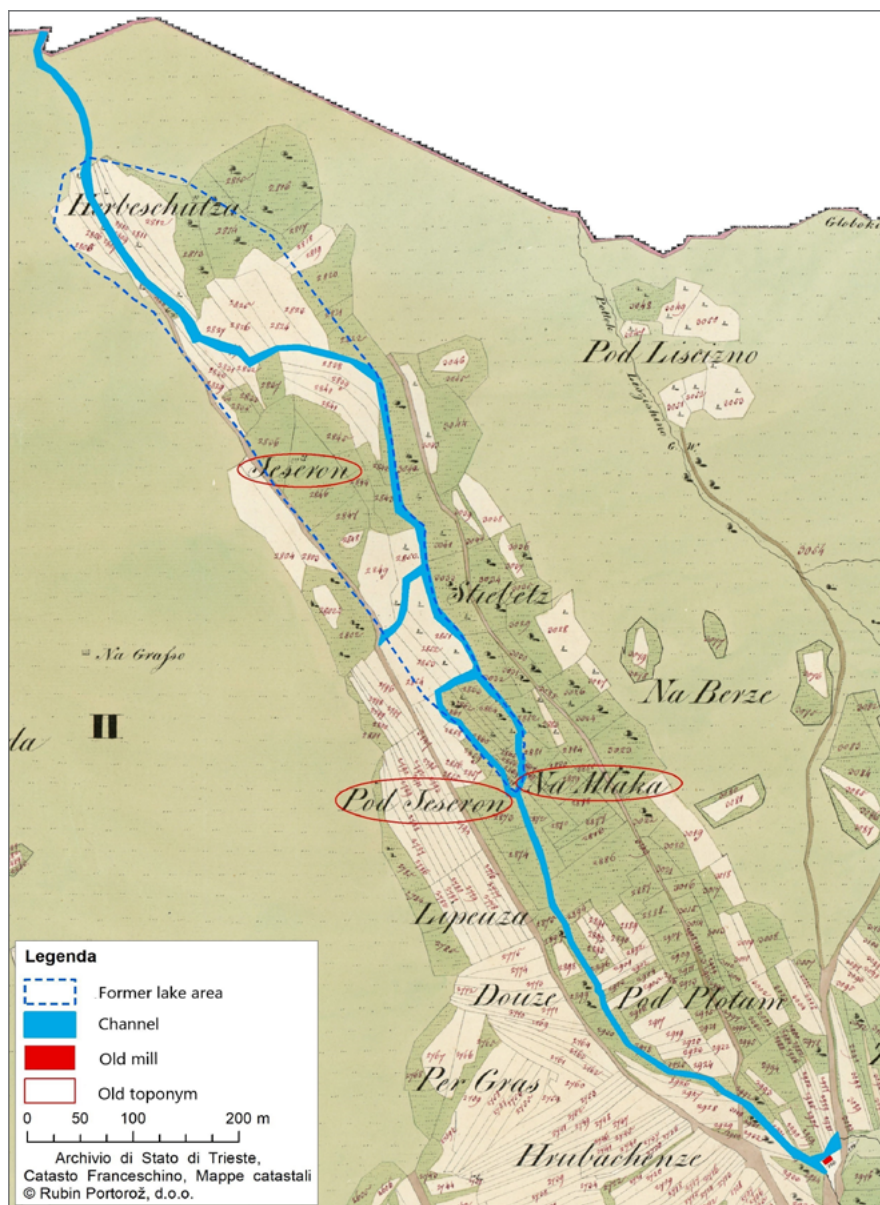
**Figure 9** Area of the Old Mill with an Artificial Reservoir, Canal and Former Lake

Another similar example is the mill in the village of Rodik. The map in the Franciscan Cadastre shows a larger channel there, accompanied by the place names ‘Pod Jeserom’ (‘Below the Lake’) and ‘Jeseron’ (‘Lake’). There is no lake visible, but the land is parcelled out in the shape of a lake, which apparently disappeared in the early nineteenth century. On the cadastral map, a reservoir is marked by the above-mentioned channel, next to which there are two building plots. One of them bears the name ‘Stari mlin’ (Old Mill), which means that a mill once operated there. From this we can conclude that at the time of the creation of the Franciscan Cadastre there was less water in this area than in the more remote past. We can find out what kind of watercourse it was from the list of plots, because the above-mentioned channel has its own cadastral number and belongs to the group of ‘ponds and drainage channels’ (*Lach und Ableitungs Gruben*). So, the channel that starts at the reservoir next to the ‘old mill’ is a drainage or water channel, which is definitely the result of artificial water regulation in the area once occupied by a ‘lake’ (figure 9). This old mill is also mentioned in the folk tradition:
